XVIIth World Congress of the International Commission of Agricultural and Biosystems Engineering (CIGR)

EVALUATING THE PERFORMANCE OF VEGETATIVE TREATMENT SYSTEMS ON OPEN BEEF FEEDLOTS IN THE MIDWESTERN UNITED STATES

CSBE101057 – Presented at Section II: Farm Buildings, Equipment, Structures and Livestock Environment Conference

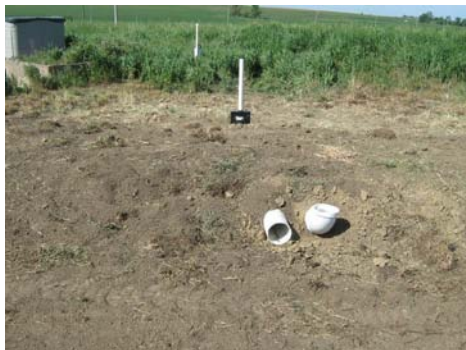
Figure 2. Northwest IA 1 constructed an earthen berm located in front of the VTA outlet.

Northwest Iowa 1 The research portion of the VTS consisted of one SSB releasing effluent onto one VTA. Concrete spreaders were used to evenly apply effluent across the top of the VTA. Monitoring equipment was installed at the SSB and VTA outlet to measure and sample flow leaving each component. An earthen berm was constructed before the VTA outlet during June of 2009 to minimize releases resulting from direct rainfall onto the VTA. The berm was approximately 0.3 meters (12 inches) tall and contained two separate effluent outflow pipes to safely release ponded effluent located within the VTA (figure 2). The first pipe contained a gate valve allowing the producer to control the amount of runoff ponded in the bottom of the VTA to minimize vegetation stress from saturated soil conditions. The second pipe served as an emergency overflow system to safely remove effluent in the case of a large ponding event. Runoff released from either of these pipes did not necessarily mean a release to surface waters. Effluent from this VTA received further vegetative treatment before leaving the system through a monitored H-flume outlet.

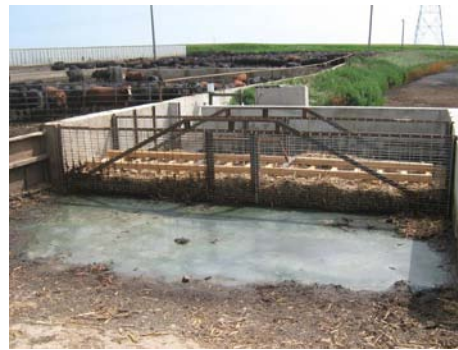
Figure 3. Northwest Iowa 2 SSB filter design

transfer the effluent to a gated pipe at the top of the VTAs. In 2009, an additional VTA was constructed increasing, the VTA total to three. The new VTA was constructed to provide a larger application area to treat feedlot runoff. The additional VTA was constructed to the east of the original VTAs and utilized the same effluent application system as the original two VTAs. The total VTA plus VIB area increased from 1.61 to 1.91 hectares and changed the feedlot to VTA ratio from 1.84:1 to 1.5:1. The new VTA became fully operational and began accepting effluent from the VIB in August 2009. The SSB outlet structure was also modified in 2009 to utilize an organic filter to provide further effluent treatment before entering the VIB. The filter design consisted of a 6.1 by 9.1 meter (20 by 30 foot) concrete structure (figure 3) with a sloped entrance ramp for solids and filter removal. Two steel fabricated fences extended across the structure to confine the filter material and to keep it from floating away with the effluent. After the filter was operational, square wooden posts were bolted together and placed on top of the filter material to compact the material and help keep it in place. The producer has experimented with various filter materials, including corn cobs and soy bean stover.
